February 12, 2015

Subject: Final Little City Building Ottawa Findings Report
EPA Contract No. EP-S5-13-01
Technical Direction Document No. S05-0001-1501-001
Document Tracking No. 0146

**FINAL FINDINGS REPORT
FOR THE
LITTLE CITY BUILDING SITE
OTTAWA, MARION COUNTY, ILLINOIS**

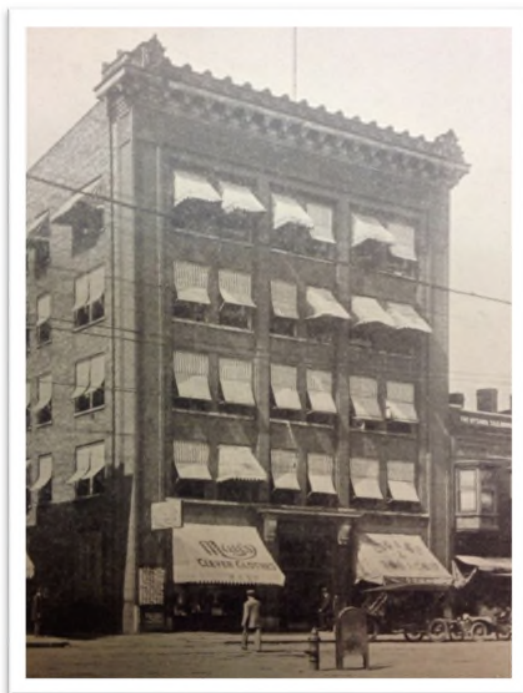
Photo #1
South Face taken in the early 20th Century

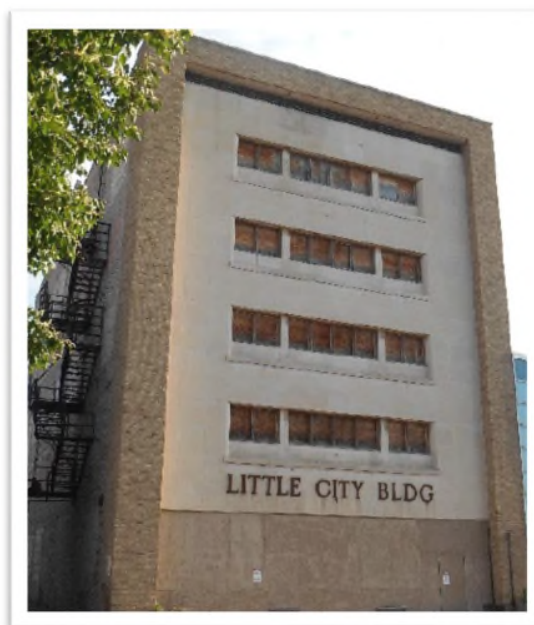
Photo #2
South Face taken late 2014

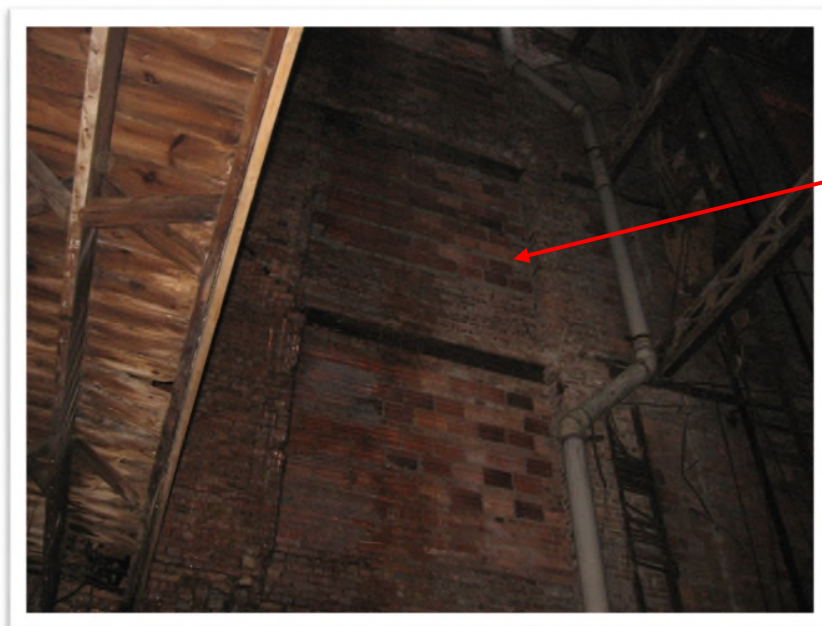
- One entire bay of floor framing (~18'x15') that abuts the west wall has collapsed from the fifth through the first floors leaving the west wall unbraced for a height of approximately 68 feet. A slight bow in the wall was observed on the exterior side at this same location.
- Adjacent bays to the collapsed bay at various levels are exhibiting signs of failure: sagging joists, split members, and framing pulling away from the exterior walls.
- Water staining is prevalent throughout and the roof membrane is severely compromised.
- The floor sheathing has deteriorated throughout.
- The stairs are heavily damaged and unsafe to use.

Photo #3
Collapsed bay, full height of building

If the decision is made to stabilize the building structure, Tetra Tech recommends employing the use of shoring beams and post shore columns for stabilizing the individual floor levels in lieu of the 2' x 8' wood framed walls recommended in the Fehr Graham letter. The construction of wood framed walls may be disruptive and will require numerous materials to be brought into the building, adding more load to the already stressed floor system. A shoring beam can be quickly set into place with a limited construction crew and quantity of materials. For stabilizing the exterior wall, Tetra Tech recommends that diagonal post shore braces be provided on the exterior west side of the building structure in addition to the horizontal beam members recommended by the Fehr Graham letter. The braces would provide additional lateral support and help to safeguard against an outward collapse of the west wall.

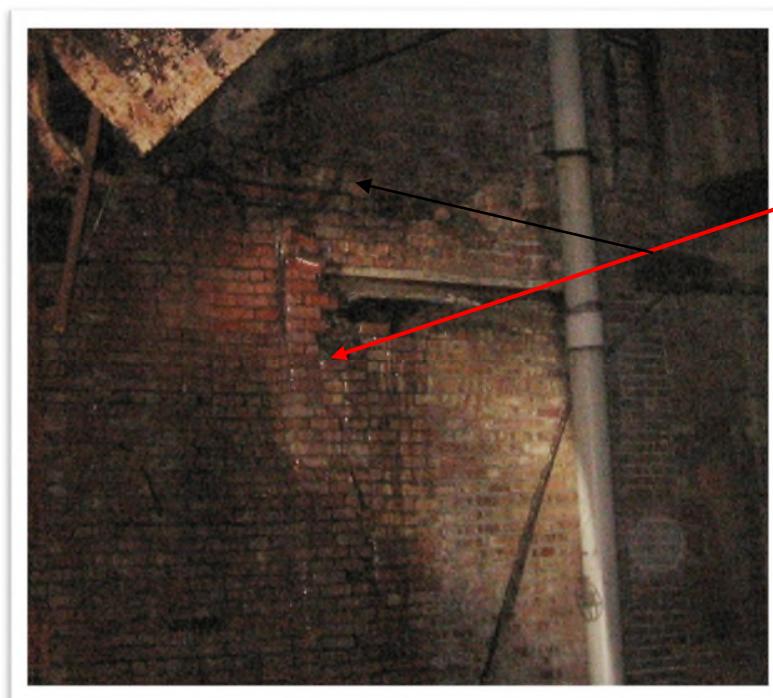
On January 28, 2015, a site visit was made by EPA OSC Brad Benning, Tetra Tech START, and officials from the City of Ottawa: Michael Sutfin and David Noble. Having knowledge of the unsafe building conditions presented in the findings of the Fehr Graham letter, a limited interior building entry was conducted. The first floor was accessed through the main entrance on the south face of the building. Tetra Tech only entered within the first 40 feet of the building which was enough to visually confirm some of the major findings outlined in the Fehr Graham letter: one bay of framing had collapsed from the fifth floor to the basement level (Photo #3); and water infiltration was prevalent as witnessed by the sagging plaster ceilings, mold, a sheet of ice along the exterior wall that abuts the collapsed bay, and water staining throughout. (Photo #4).

Photo #4
Missing wall bricks and ice along wall face

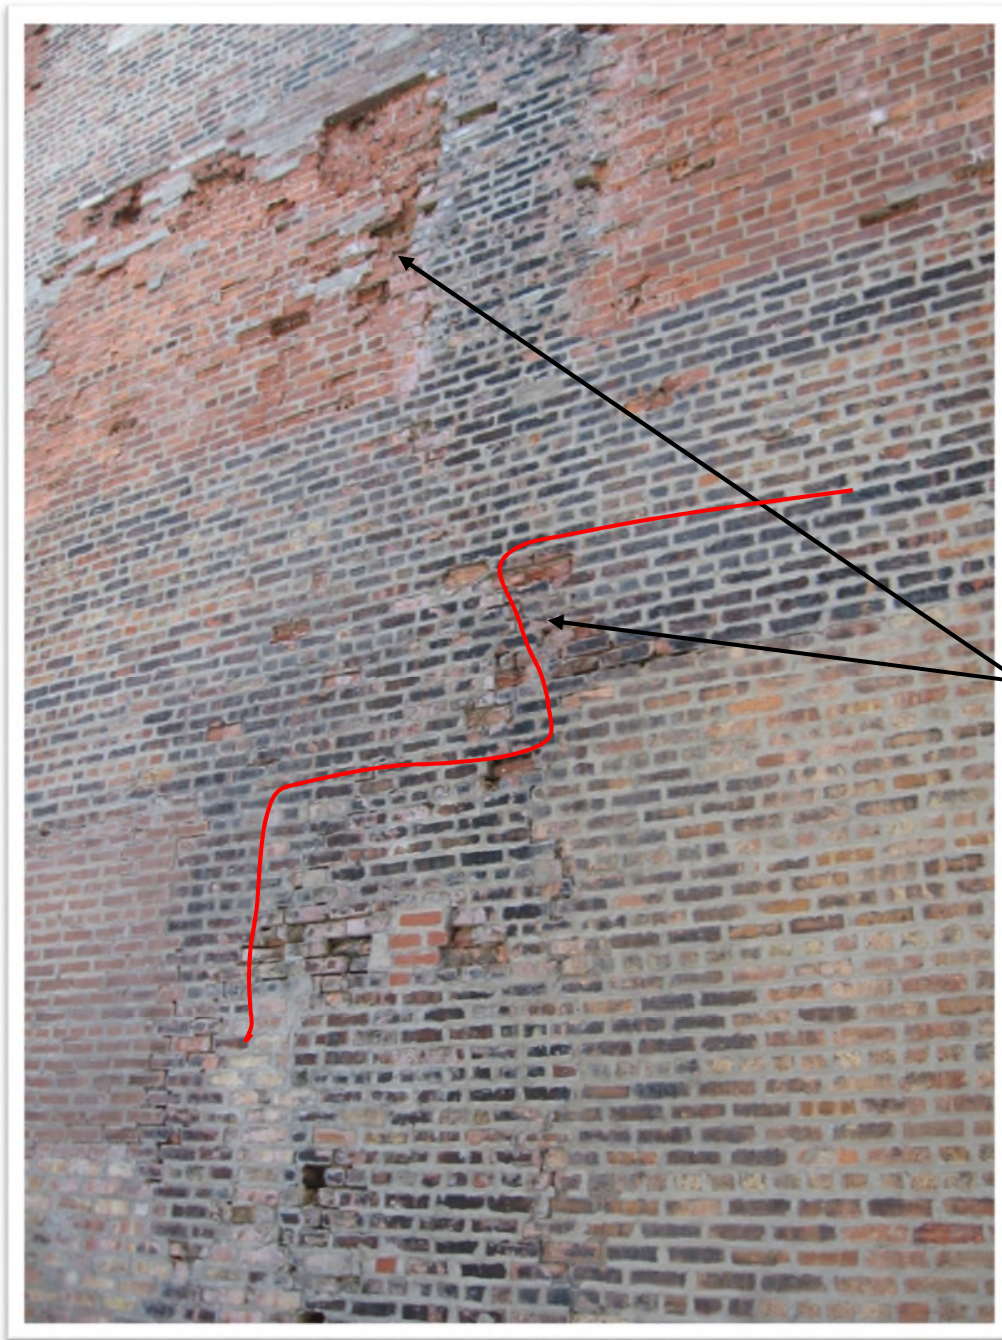
One item noticed by Tetra Tech and also mentioned by city officials in a meeting prior to the site visit was that the exterior wall that abuts the collapsed bay was damaged when presumably the bay collapsed. This was not mentioned in the Fehr Graham letter. Based on the limited visual inspection it was apparent that several wythes (layers) of brick had peeled away from the wall leaving the wall thinner than originally constructed. Furthermore, when viewed closer from the exterior side of the wall, vertical cracking was evident at this location along with loose mortar and brick debris on the ground. City officials have been visually monitoring the wall since the Fehr Graham letter and indicated during our site review that the wall cracks and debris on the ground were new and the wall looked to be in worse condition (Photos #5 and #6).

Photo #5
Missing exterior wall bricks and cracks

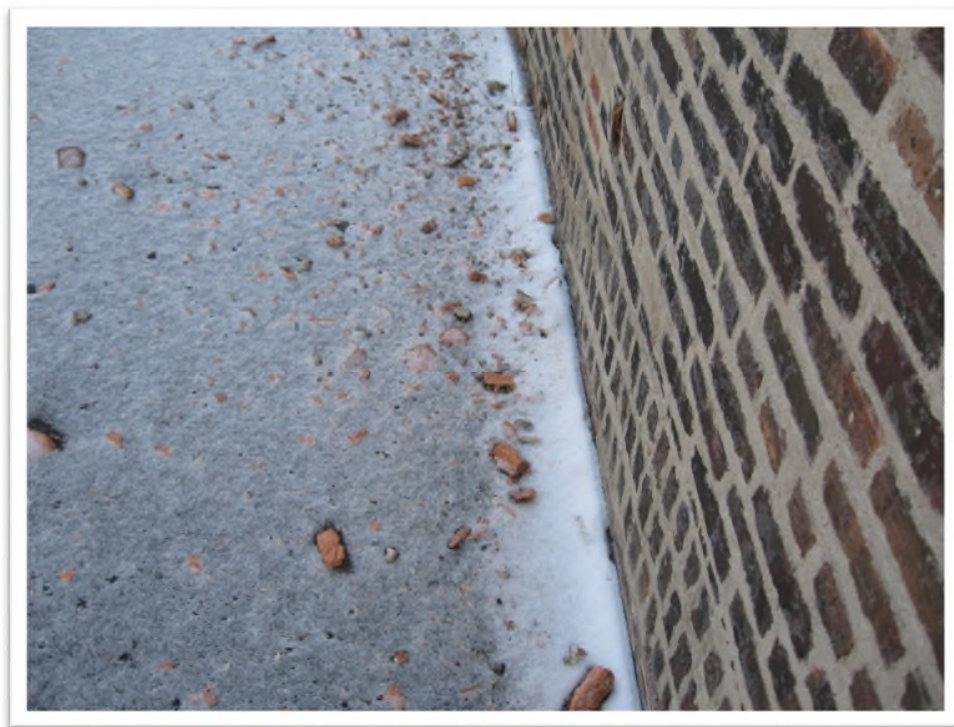
Photo #6
Missing exterior wall bricks and cracks

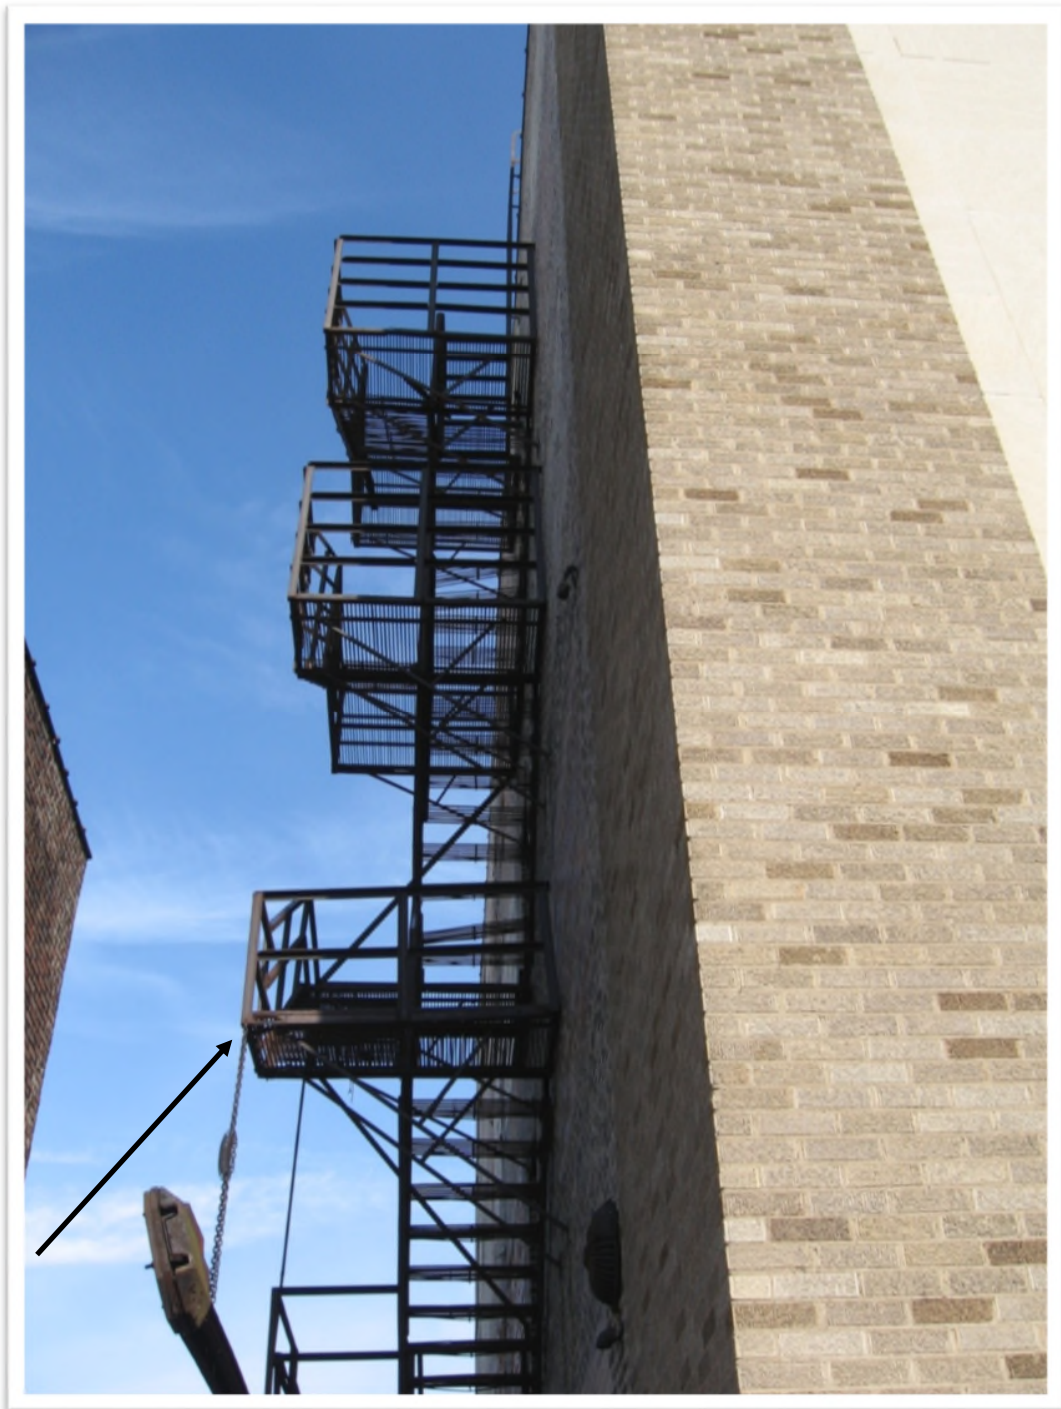
A visual walkthrough was made around the exterior of the building. The east side of the building is adjoined by additional properties – accessing the interior of the adjacent properties was not possible. A slight bow in the wall was evident on the west side. A steel fire escape ladder and a multi-story platform is attached to the exterior southwest side of the building – immediately south of the collapsed bay (Photo #7). The ladder shows slight deformation which could be attributed to either the wall bowing, corrosion of the steel, or the anchorage of the platform to the wall beginning to fail. Soft mortar was prevalent in accessible areas on the exterior of the building. Evidence of prior tuck pointing operations was noticed. Other than the cracking at the collapsed bay location, no other significant wall cracks were evident on the exterior side.

Photo #7
Exterior fire escape, lower level bowing out
